# VEHICLE INSPECTION REPORT

**PE17HTU**

## Daf CF 440

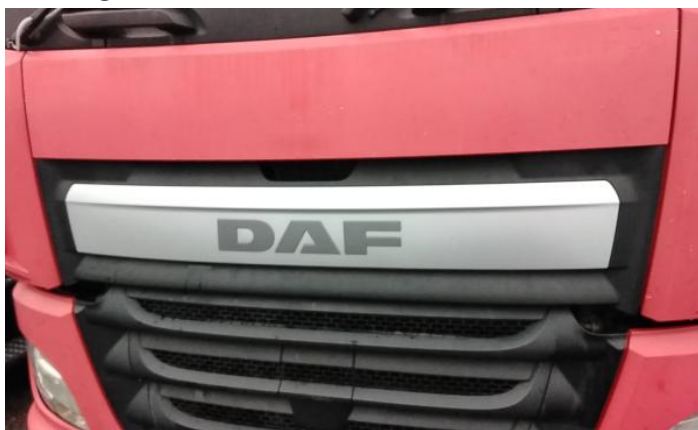
1: Bonnet  
Chipped  
Multiple Chips

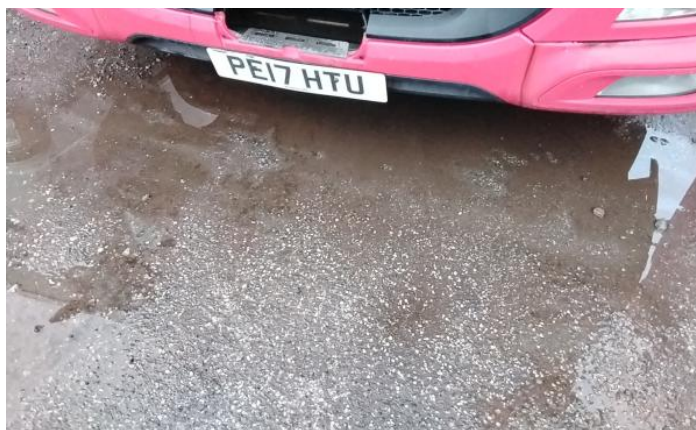
2: Bumper Front  
Scratched  
Over 100mm Thru Paint

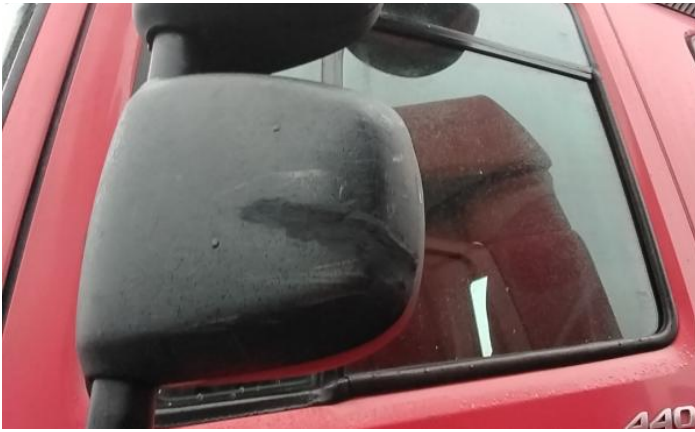
3: Door Mirror Assy nsf  
Broken  
Replace

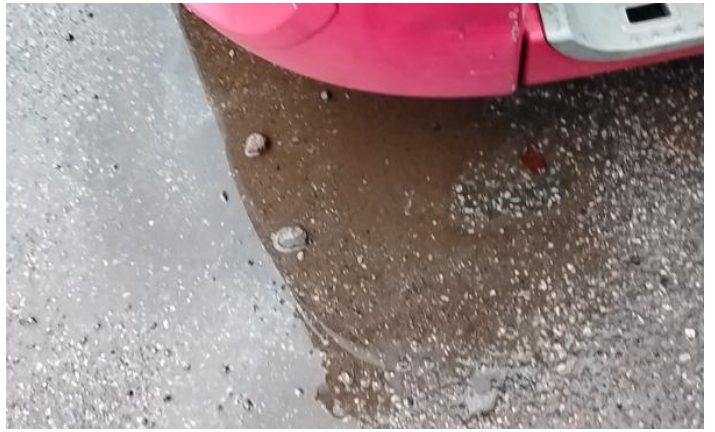
4: Bumper Front  
Dented  
With Paint Damage

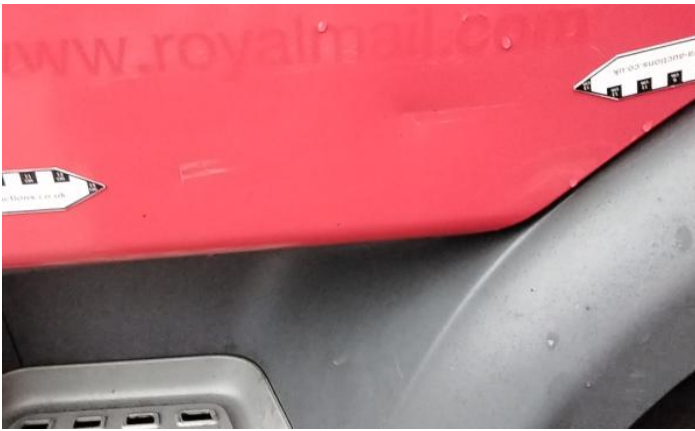
5: Door nsf  
Dented  
With Paint Damage

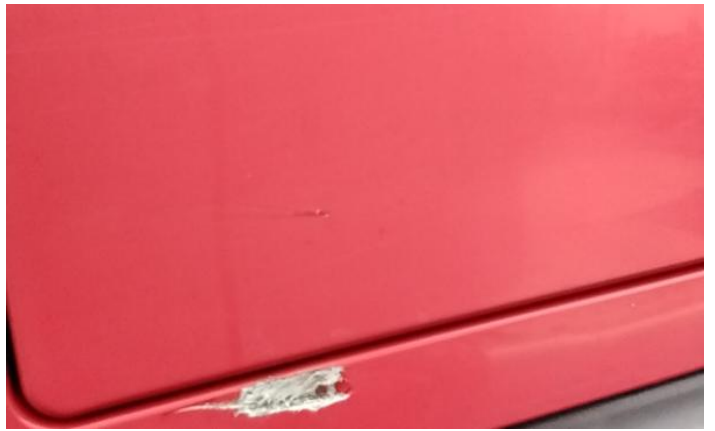
6: Qtr Panel Moulding ns  
Broken  
Replace

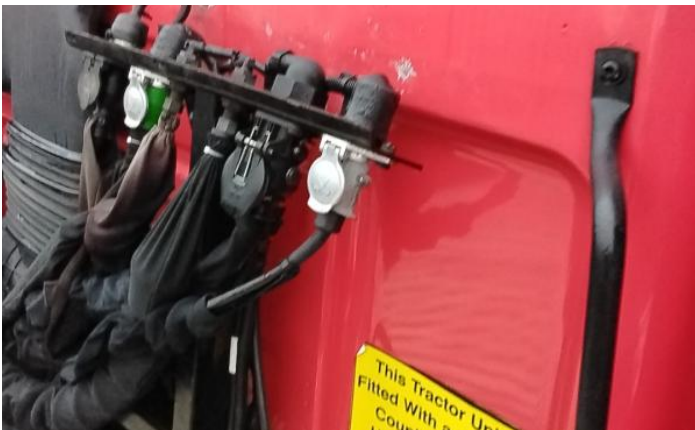
7: Panel Rear  
Dented  
With Paint Damage

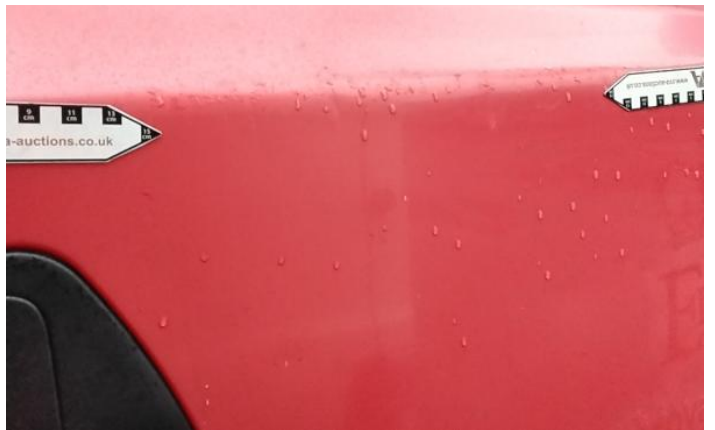
8: Door osf  
Dented  
Over 30mm

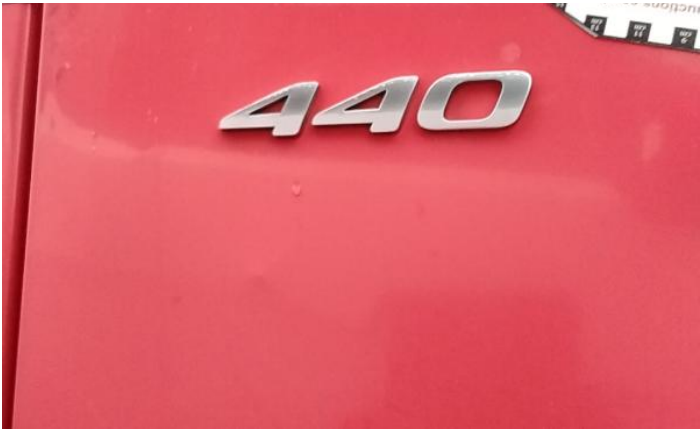
9: Door osf  
Scratched  
Over 25mm Not Thru Paint

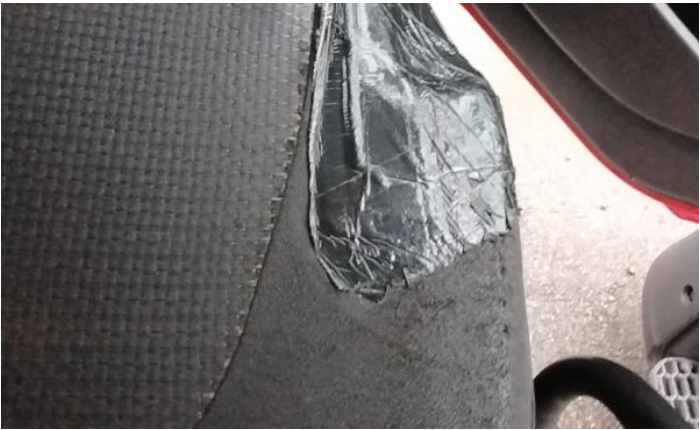
10: Seat Base Cover osf  
Holed  
Over 3mm
