# VEHICLE INSPECTION REPORT

**SG13OEO**

## Peugeot Bipper 1.3 HDi 75 S

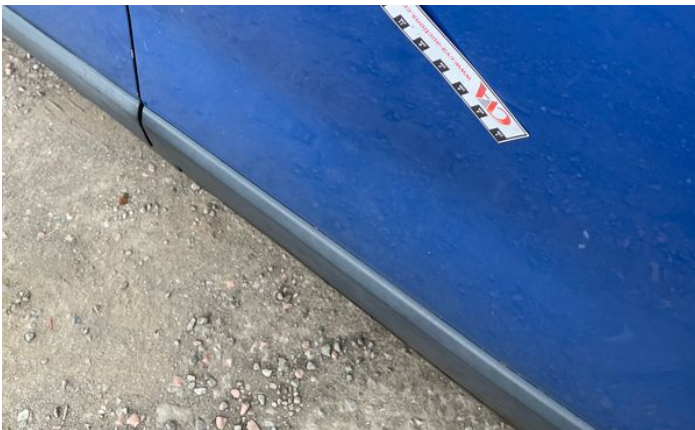
7: Door nsr  
Dented  
With Paint Damage

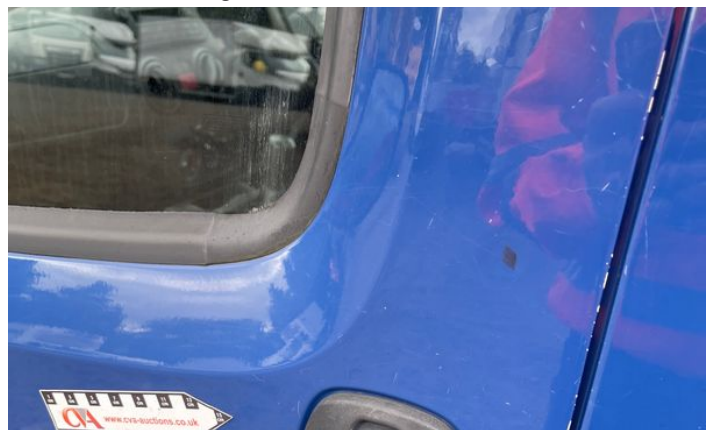
8: Door nsf  
Dented  
Over 30mm
