# VEHICLE INSPECTION REPORT

**DG17KUH**

## Daf CF 330

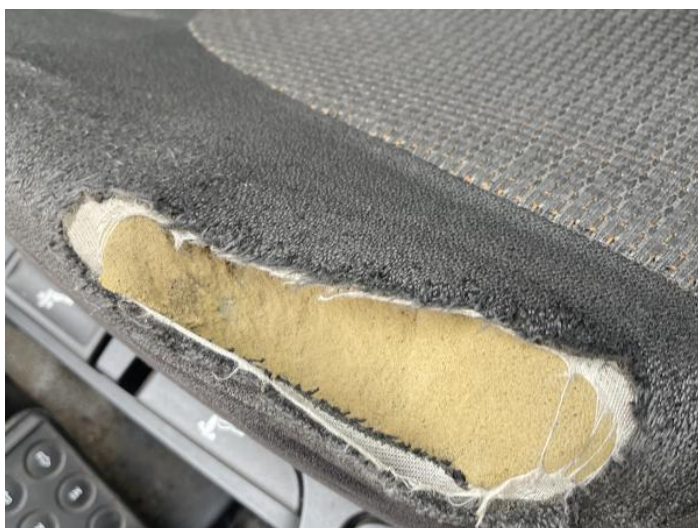
1: Seat Base Cover osf  
Torn  
Over 3mm

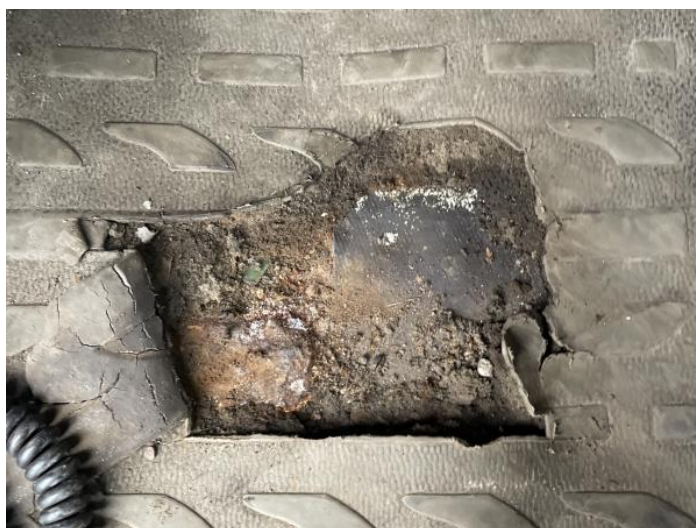
2: Carpets Front  
Torn  
Over 10mm

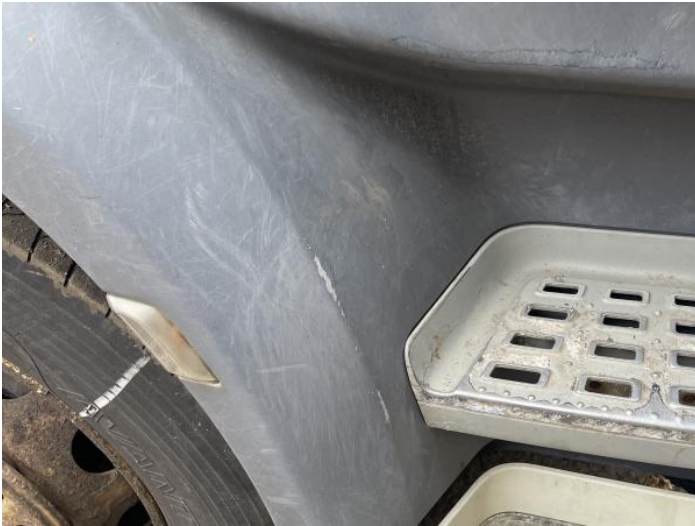
3: Door Moulding osf  
Scuffed (Unpainted)  
Over 100mm

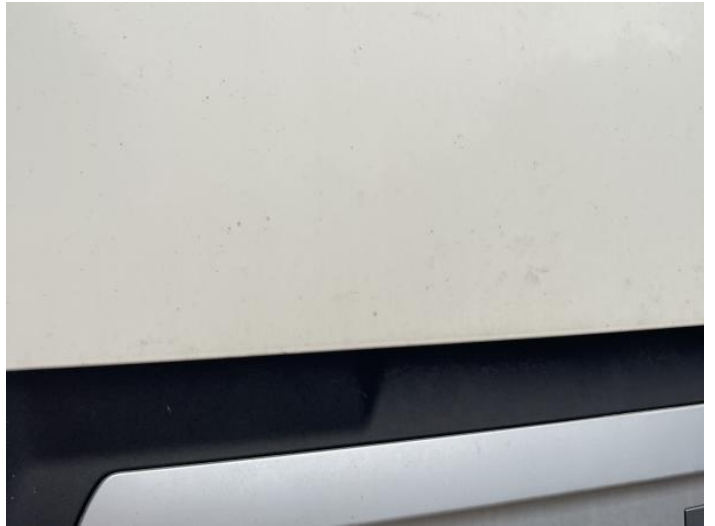
4: Bonnet  
Chipped  
Multiple Chips

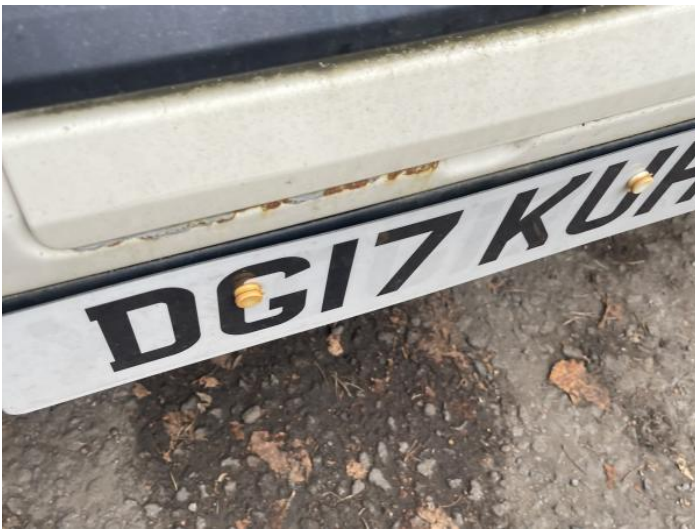
5: Bumper Front  
Rusted  
Over 5mm

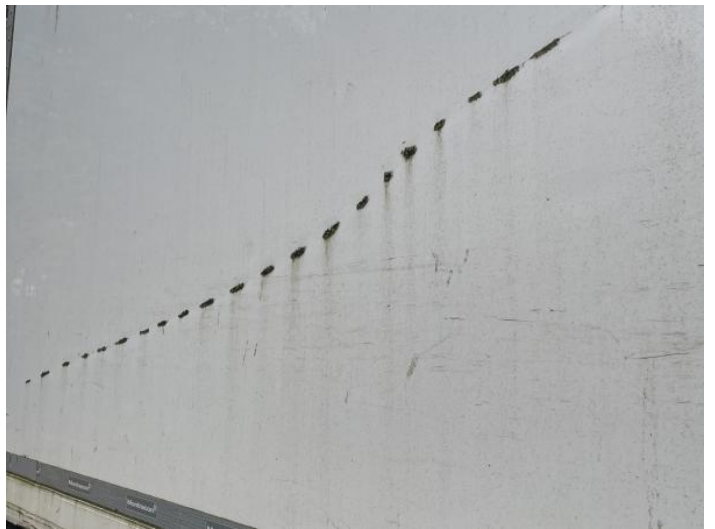
6: Qtr Panel osr  
Dented  
Over 30mm

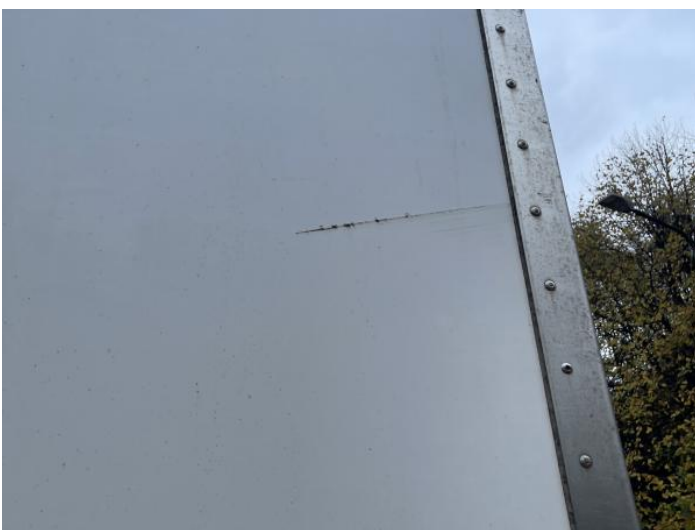
7: Qtr Panel nsr  
Dented  
Over 30mm

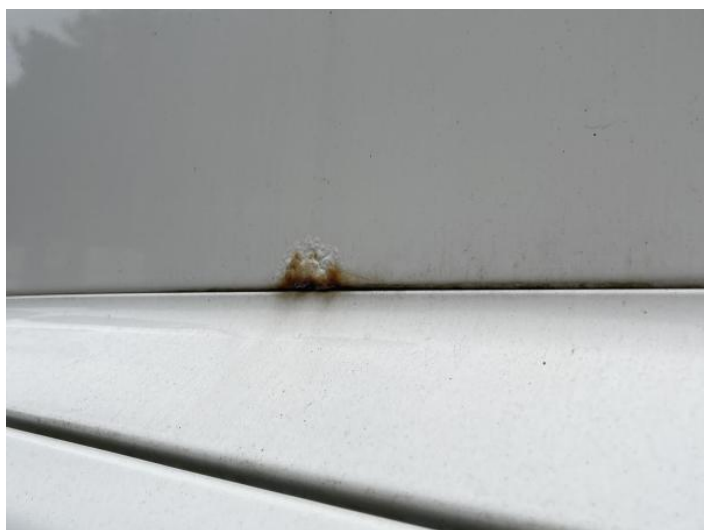
8: Door osf  
Rusted  
Over 5mm

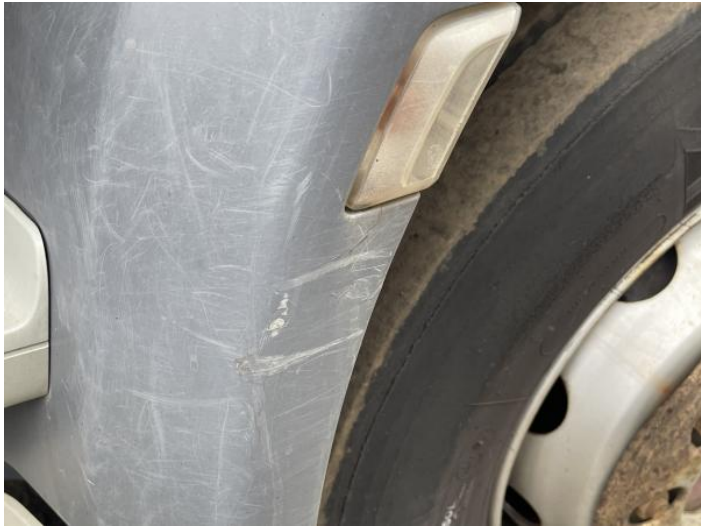
9: Door Moulding nsf  
Scuffed (Unpainted)  
Over 100mm
