# VEHICLE INSPECTION REPORT

**CN69VXM**

## Mercedes-Benz Sprinter 314 CDI

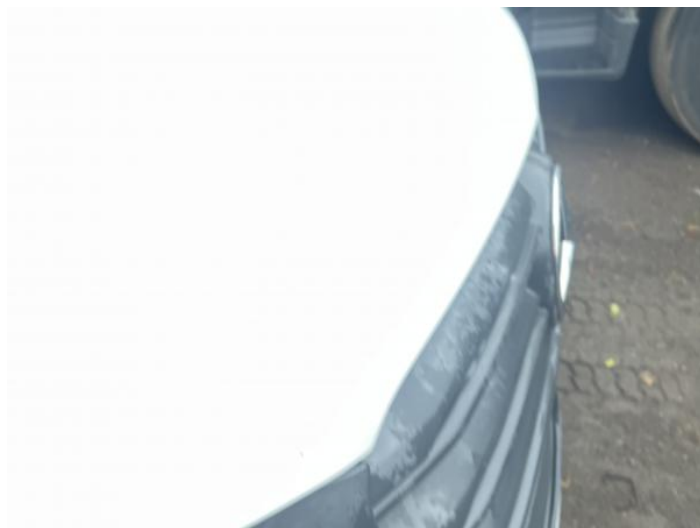
1: Bonnet  
Dented  
Over 30mm

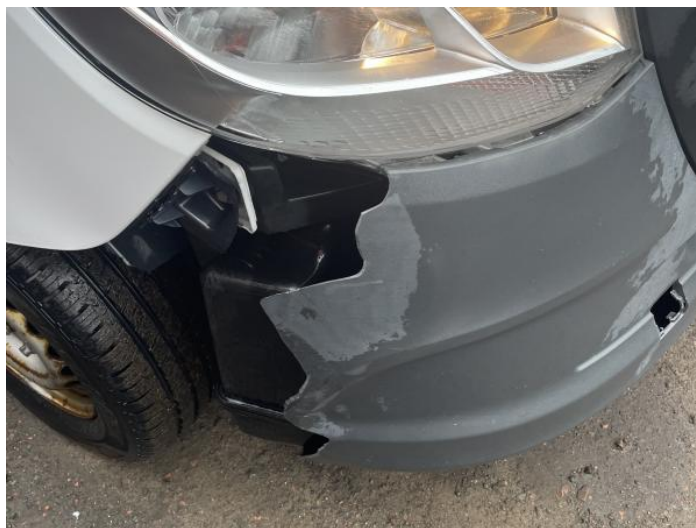
2: Bumper Front Moulding  
Broken  
Replace

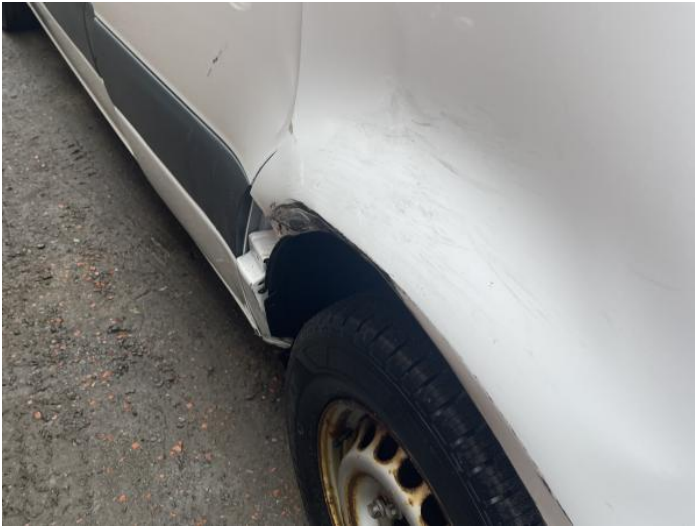
3: Wing nsf  
Dented  
With Paint Damage

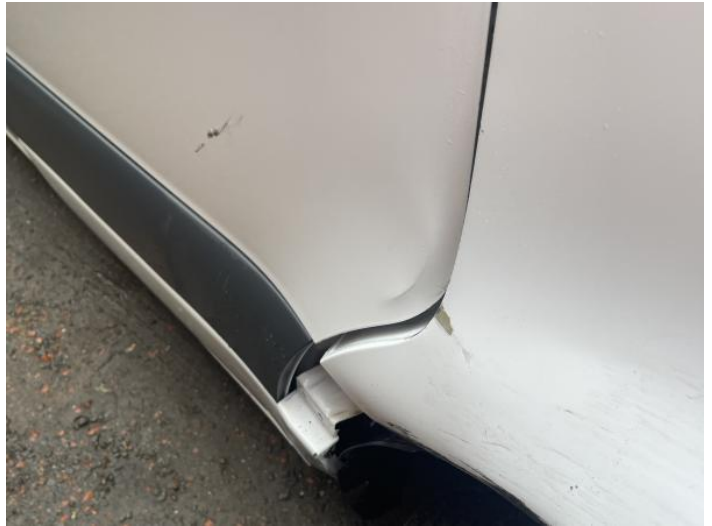
4: Door osf  
Dented  
Over 30mm

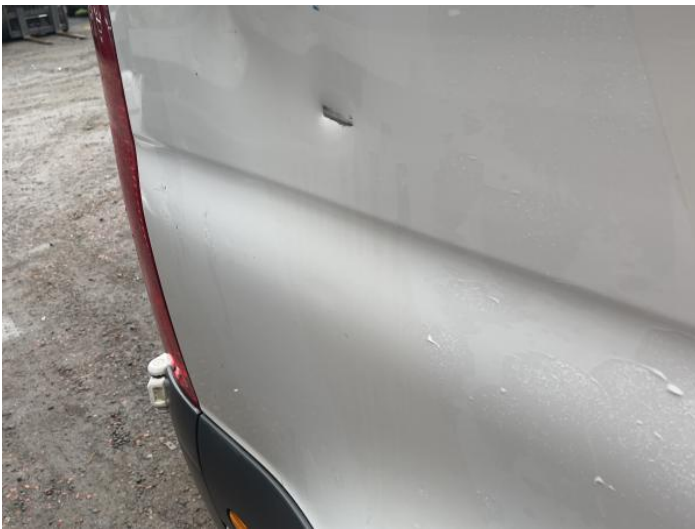
5: Qtr Panel osr  
Dented  
With Paint Damage

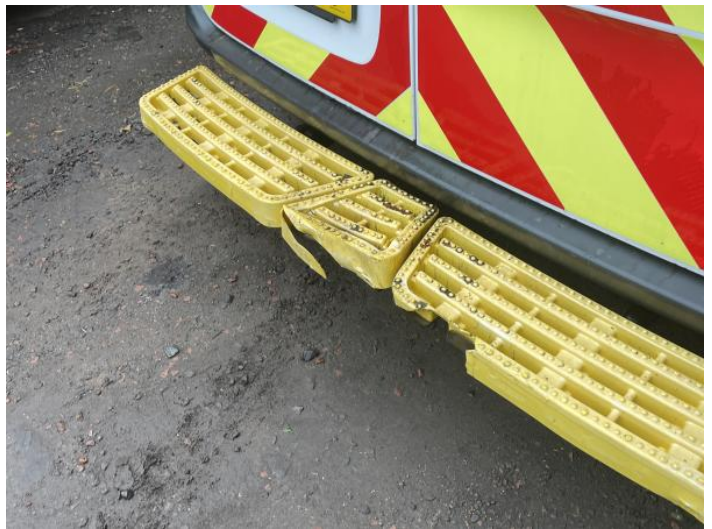
6: Bumper Rear Moulding  
Broken  
Replace

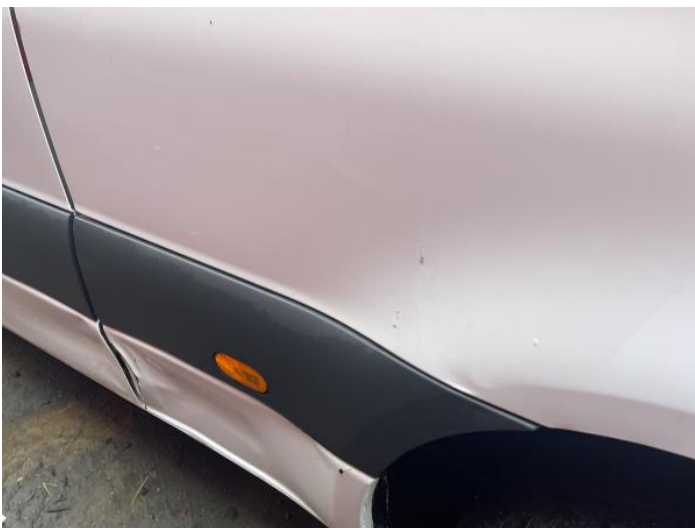
7: Qtr Panel nsr  
Dented  
With Paint Damage

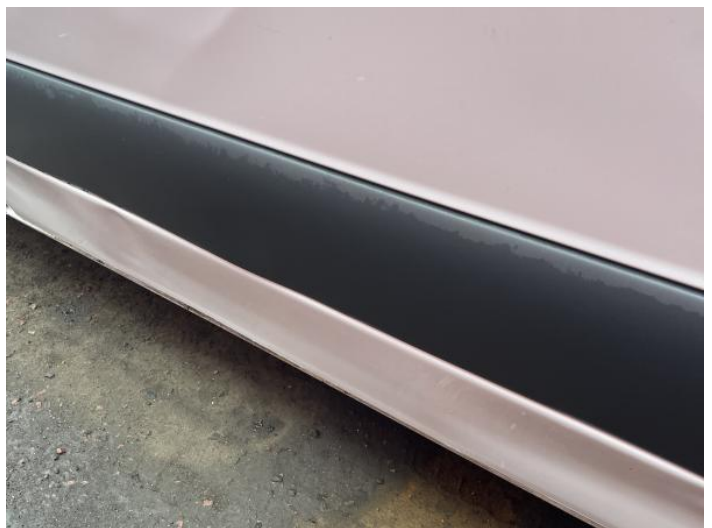
8: Door nsr  
Dented  
Over 30mm
